R A P P O R T O V E R V I N D M Ø L L E R , B I N D 4 :

V I N D M Ø L L E R P A A B O R N H O L M

En Recognosering, Analyse, og et For-
slag til en Fredningsplan, udarbejdet
1956 - 1958

Anders Jespersen, Virum, Danmark

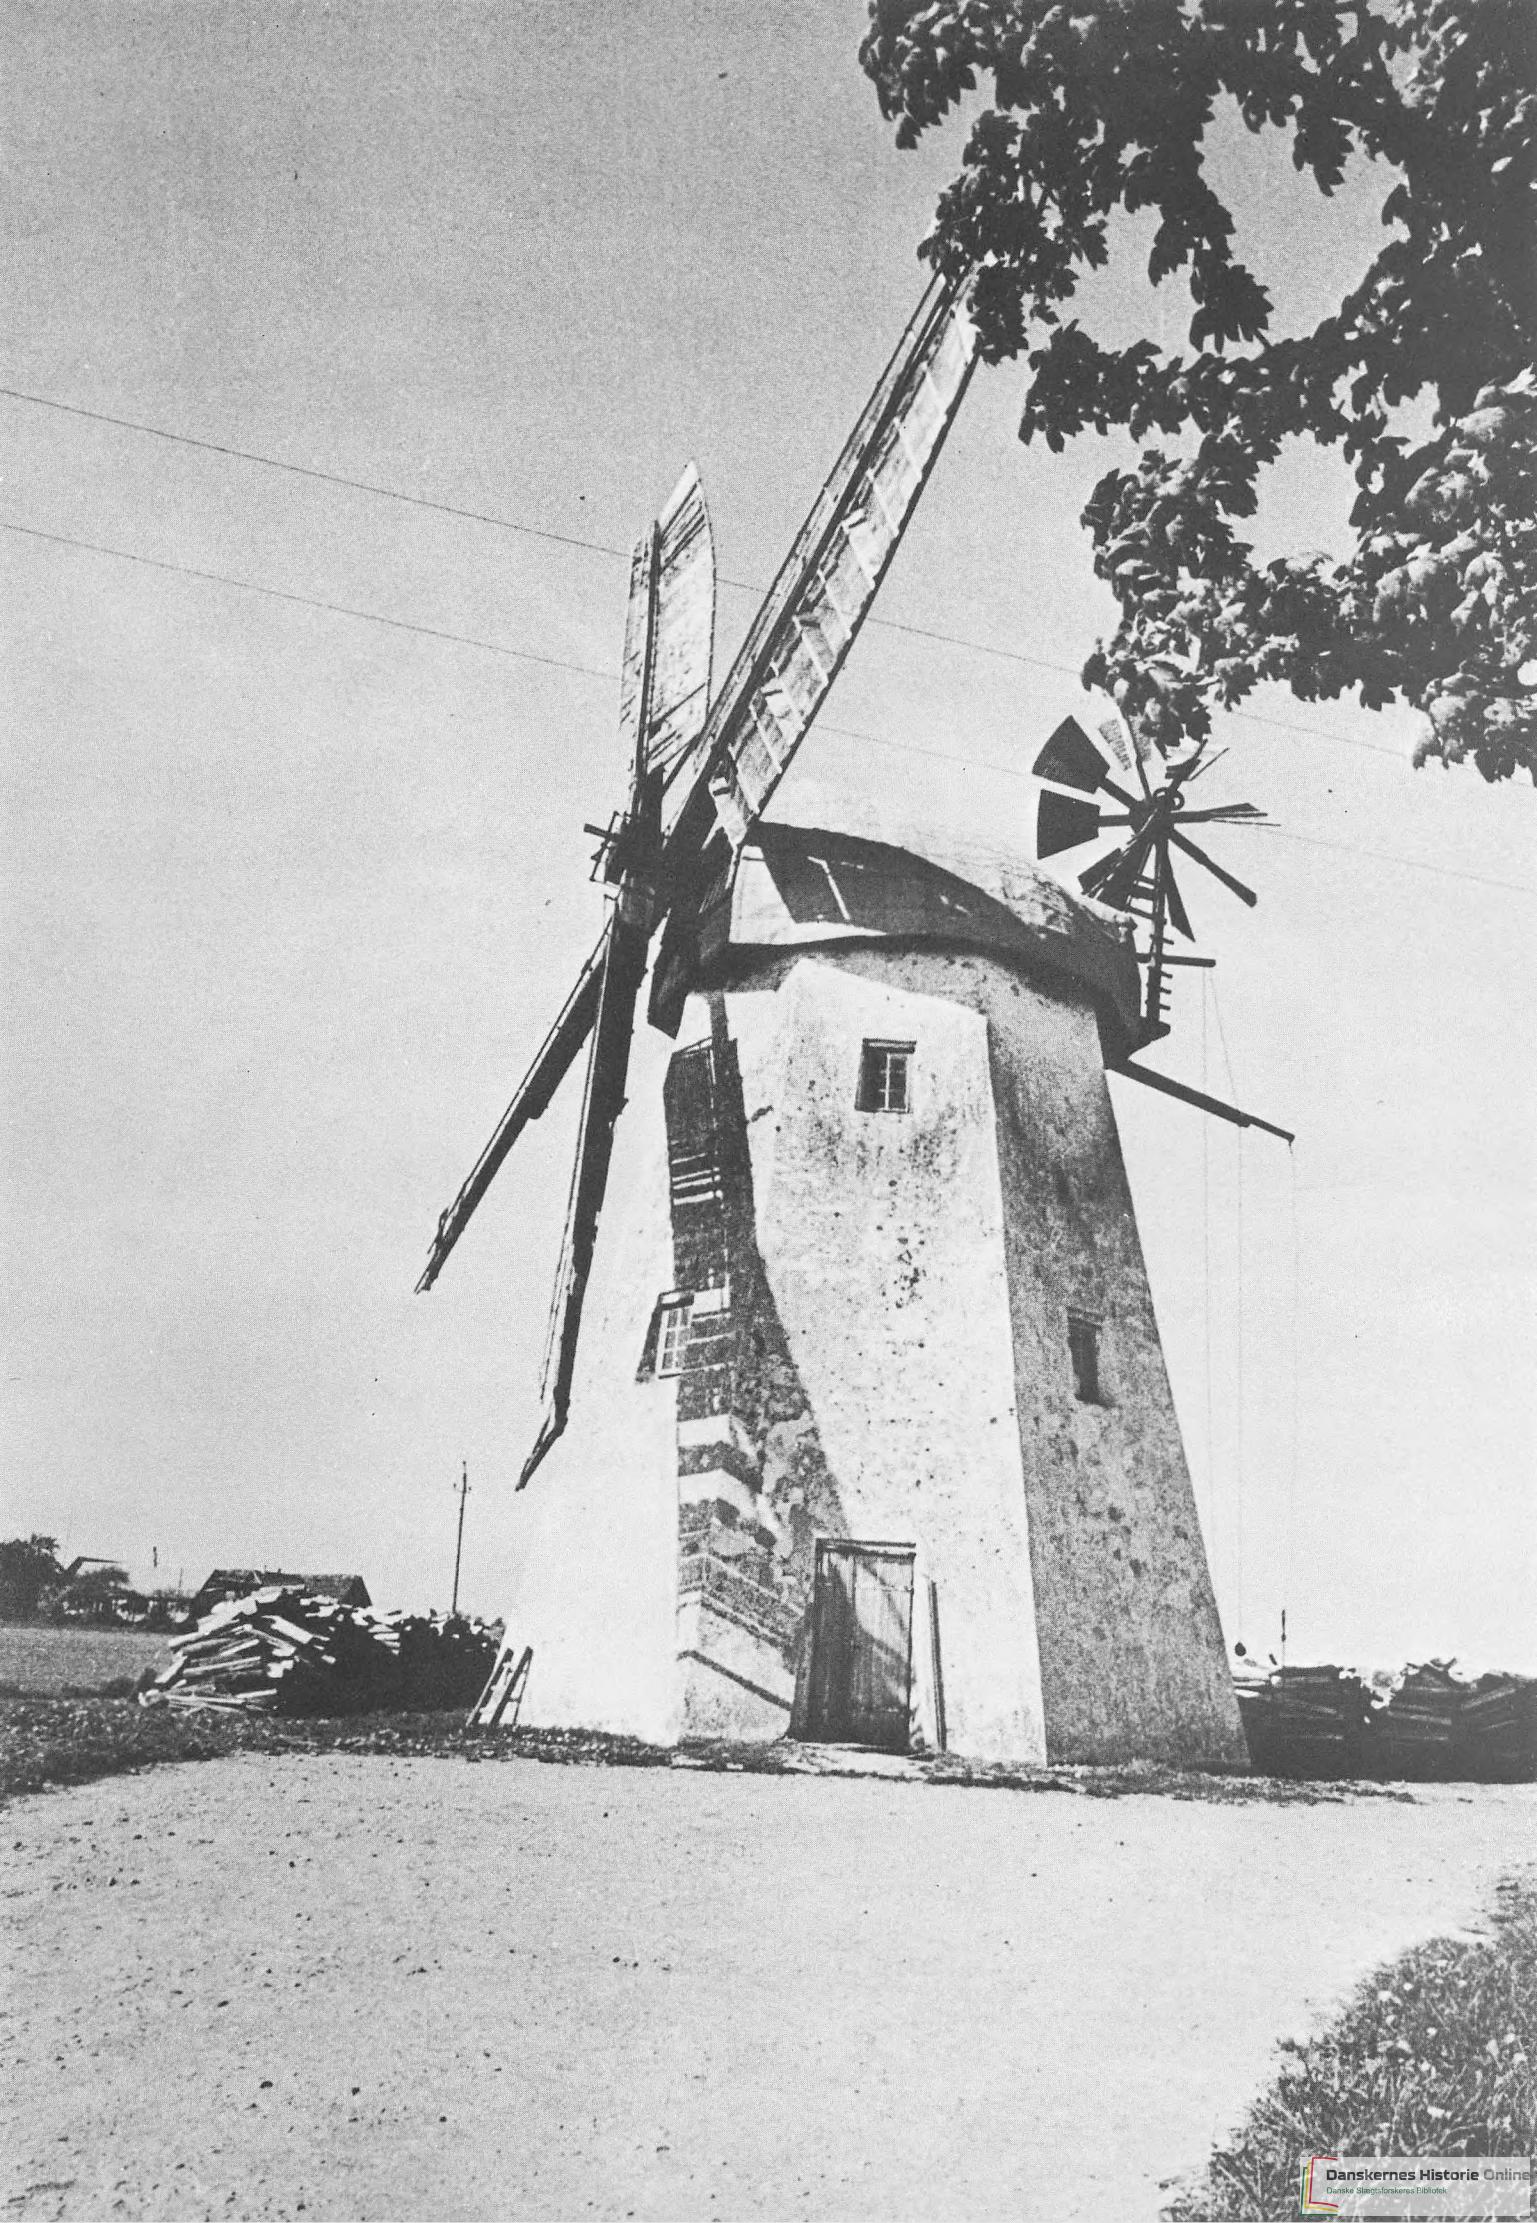
Fig. 64: DK-20 002-SAXEBRO MØLLE, date 02-06-58, neg. 830.34

The mill when it had still 4 sweeps intact. The shadow, however, betrays the decay of the shutters, and to-day only two stocks are left. It is high time to rescue this fine mill.

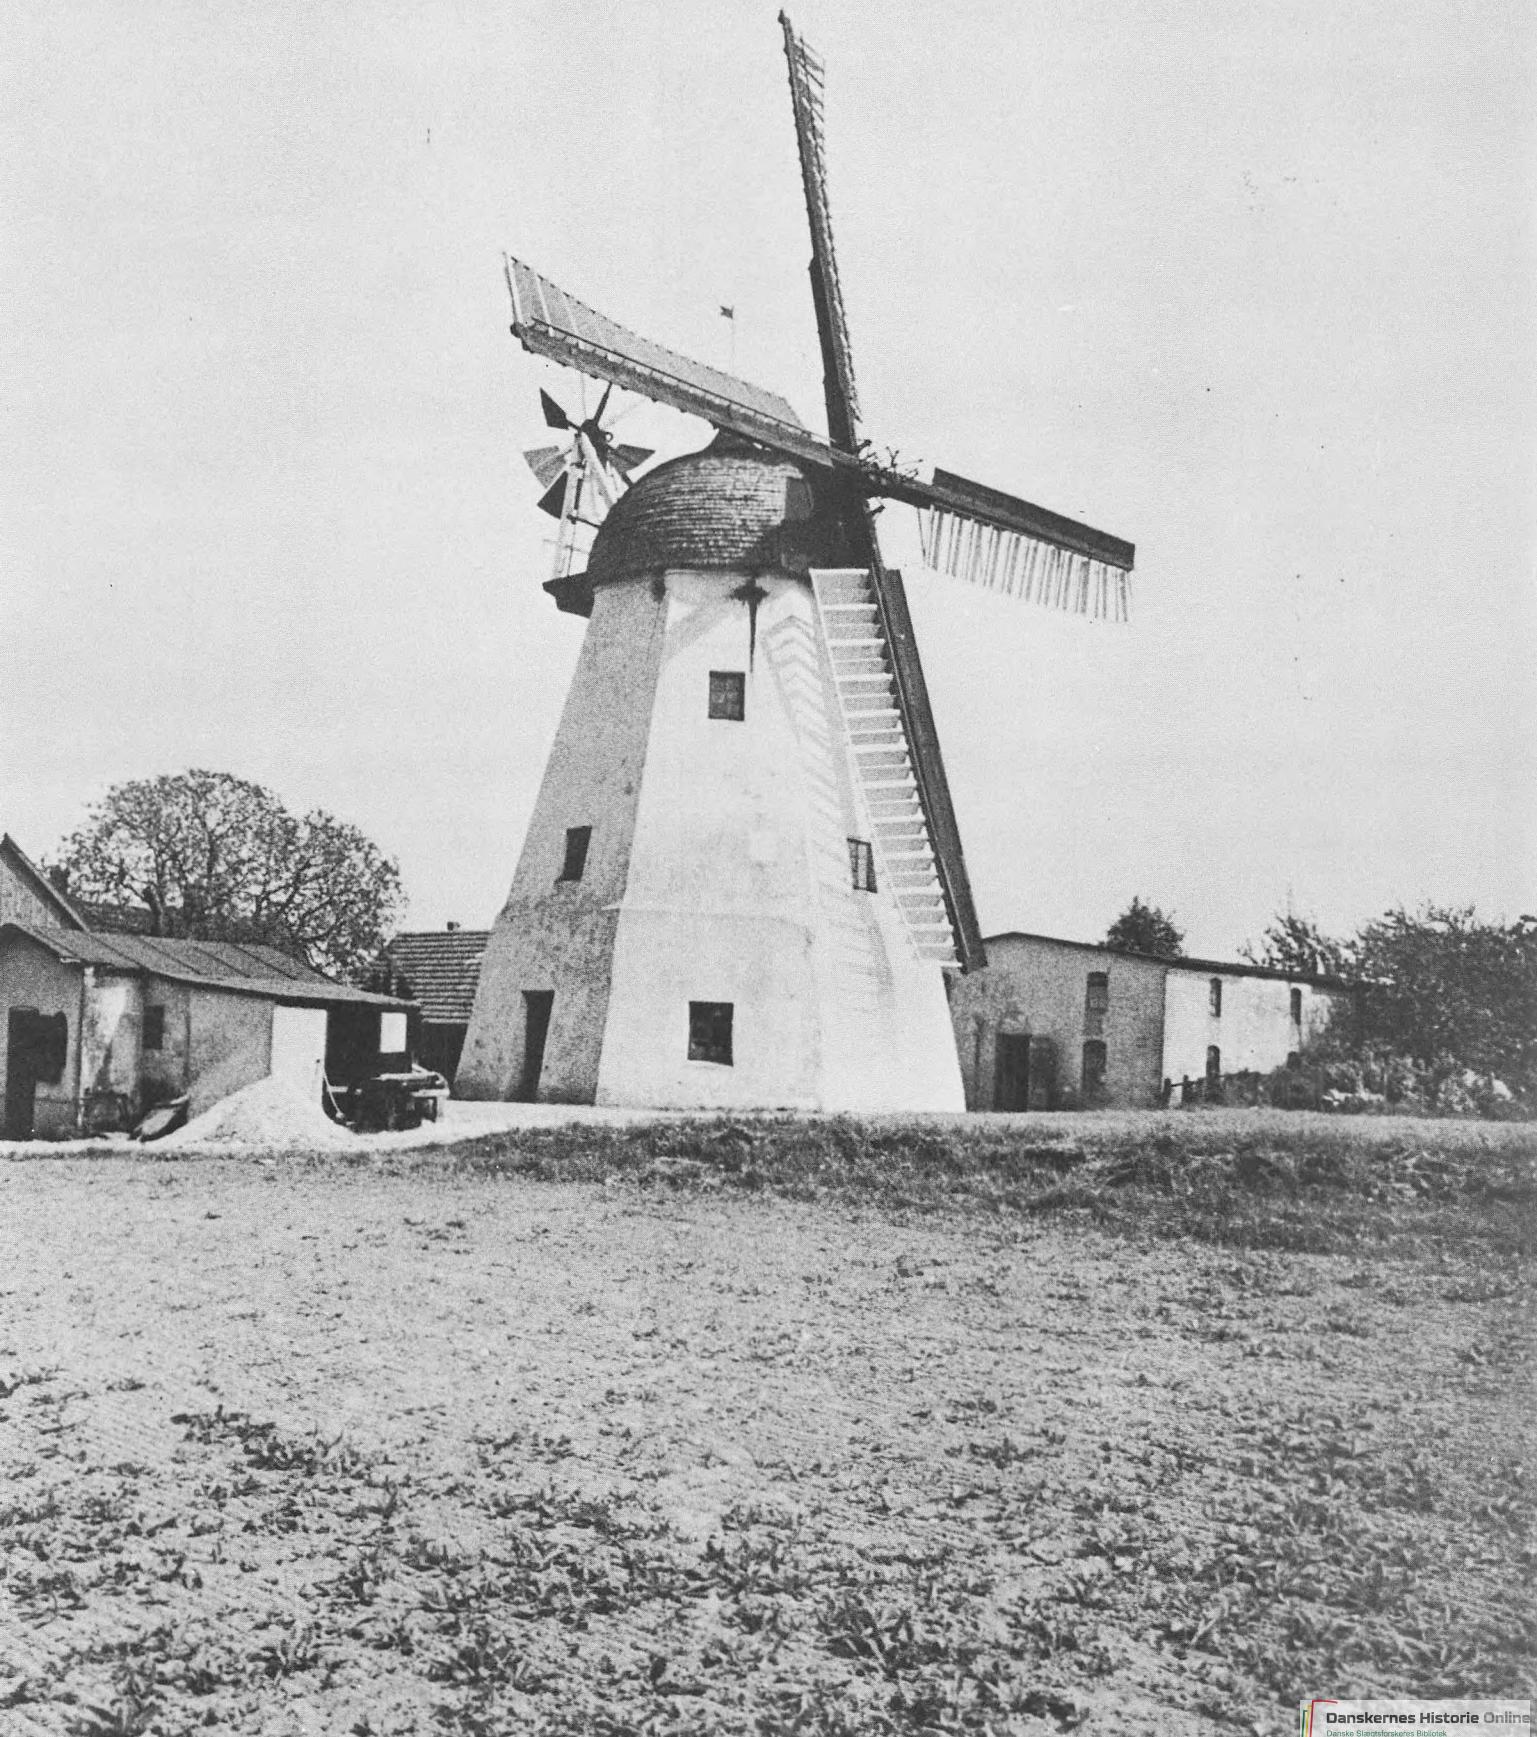
DK - 20 035 - AARSDALE MØLLE, date 04-06-56, neg. 838.19

Fig. 90: One of the best kept mills on Bornholm, still intact with all machinery, pictured in the following pages.

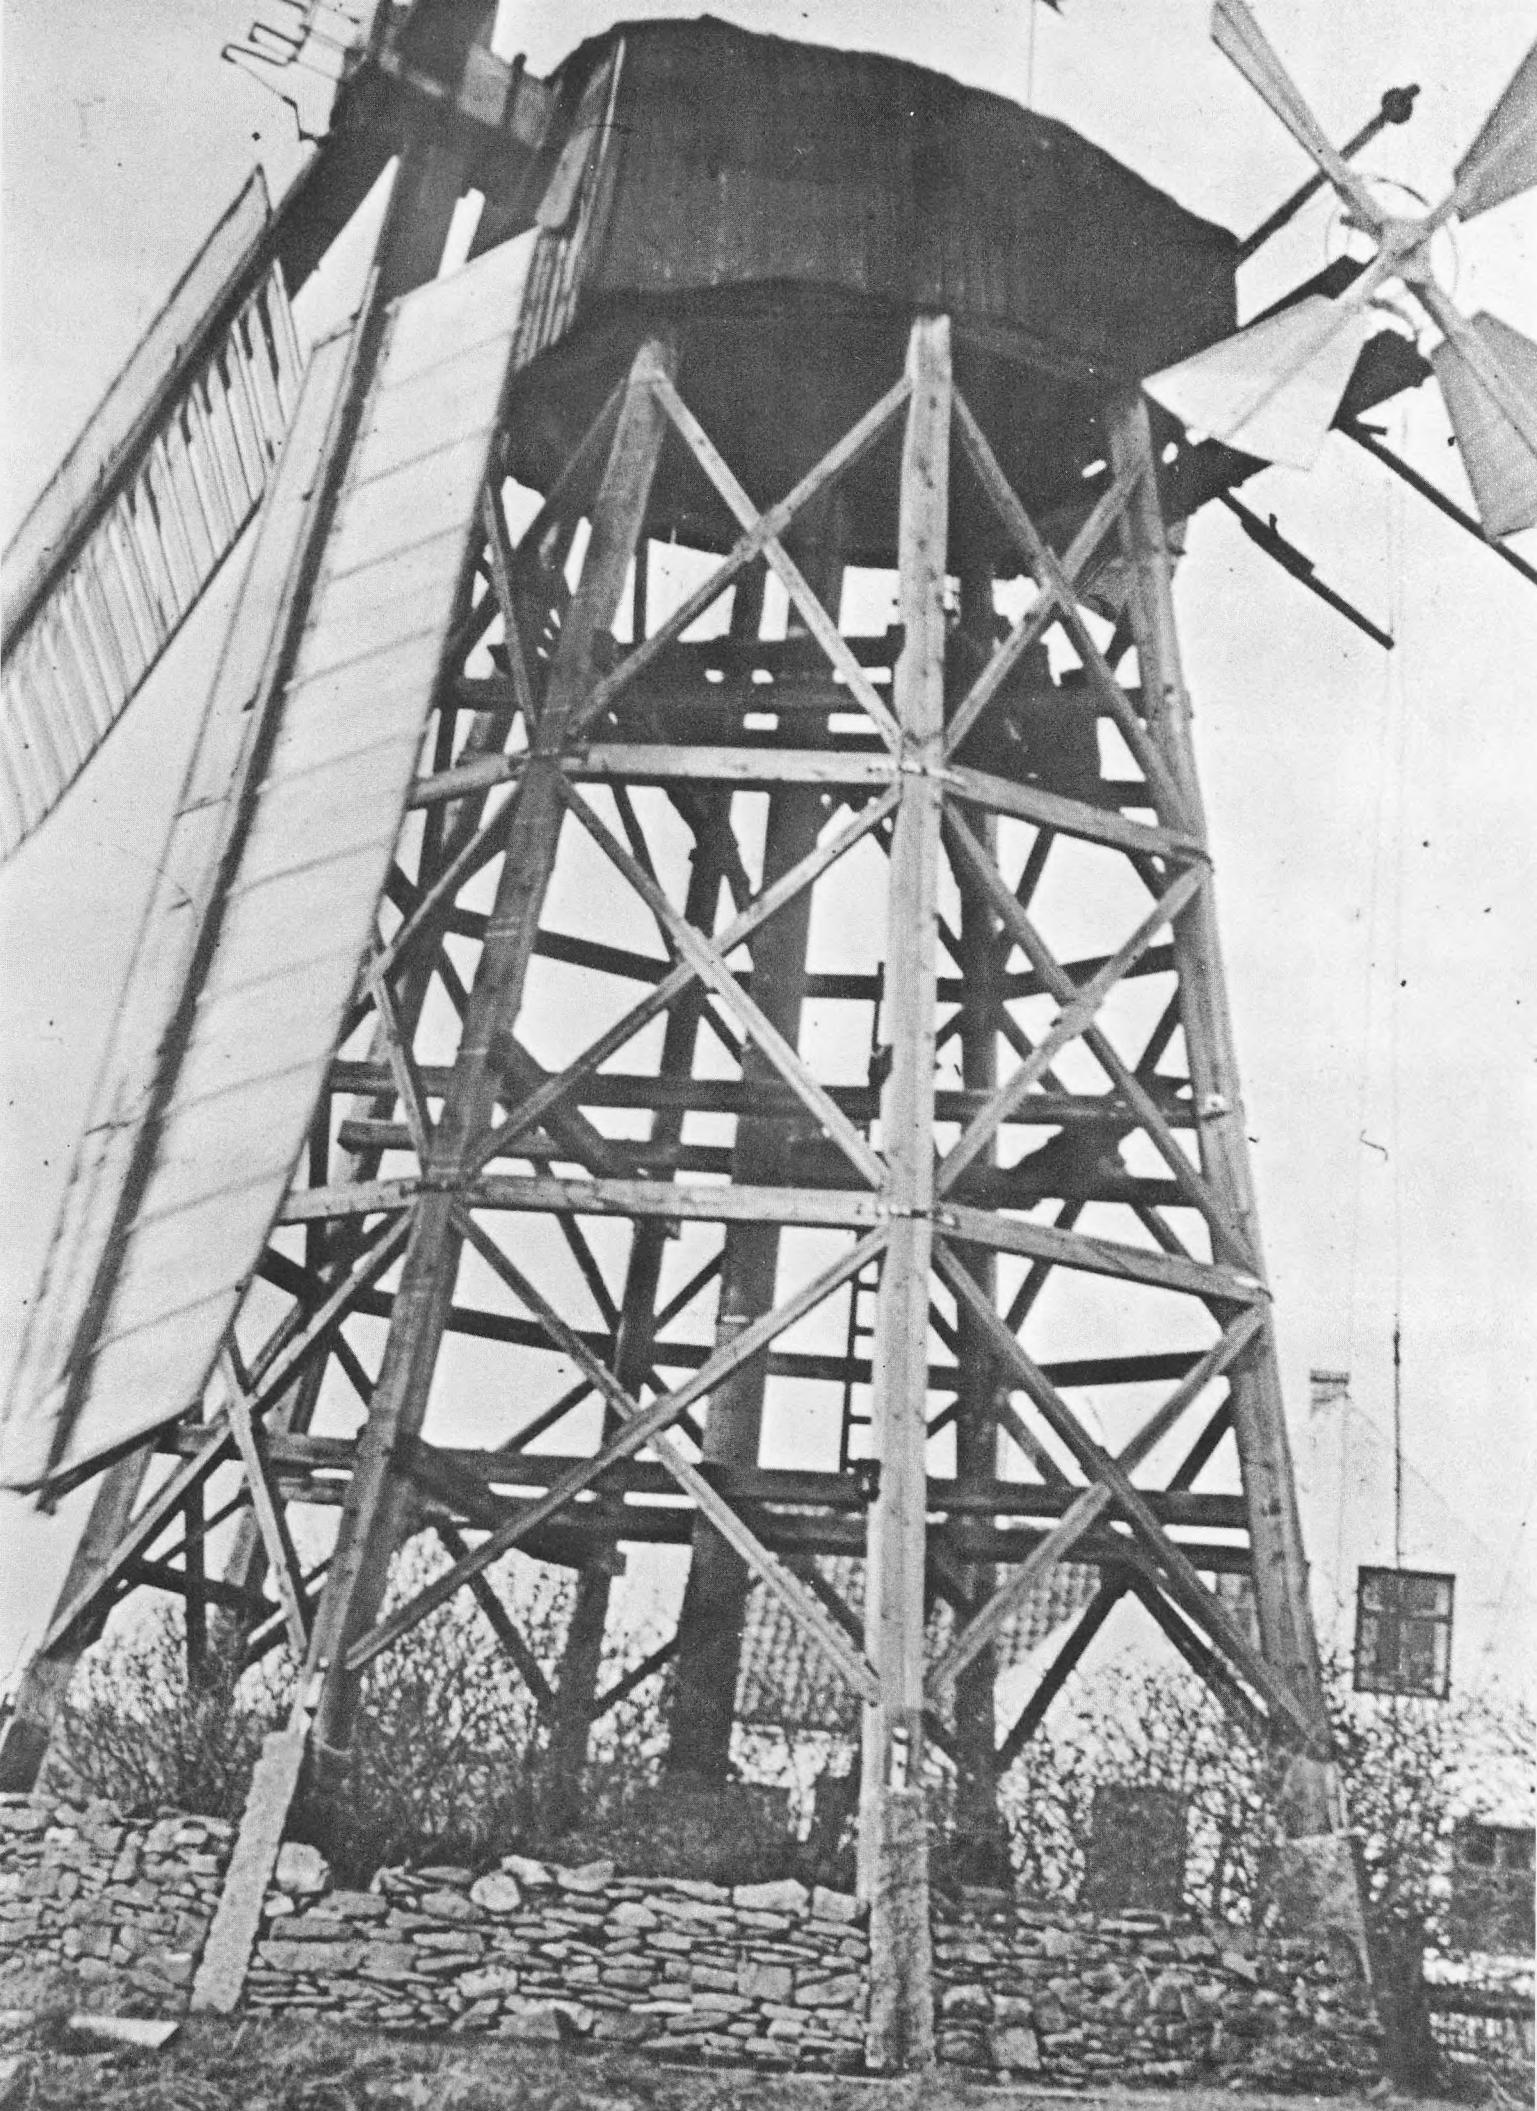
Fig. 143: DK-20 012-NEXØ SAVMØLLE, date 23-04-46, neg. 278.32

I mere end een henseende en mærkelig mølle: kroppen har aldrig været beklædt, og dog ser tømmeret friskt ud. Hatten beskytter højbenene imod vand ovenfra, og da benene staar godt fri af jorden paa granitstøtter, faar de kun lidt regn fra siden, og det tørrer hurtigt igen. Vindfanget drejer med uret, det modsatte af, hvad vi finder i de andre hattemøller. Denne mølle blev nedrevet før 1956.
