R A P P O R T O V E R V I N D M Ø L L E R , B I N D 4 :

V I N D M Ø L L E R P A A B O R N H O L M

En Recognosering, Analyse, og et For-
slag til en Fredningsplan, udarbejdet
1956 - 1958

Anders Jespersen, Virum, Danmark

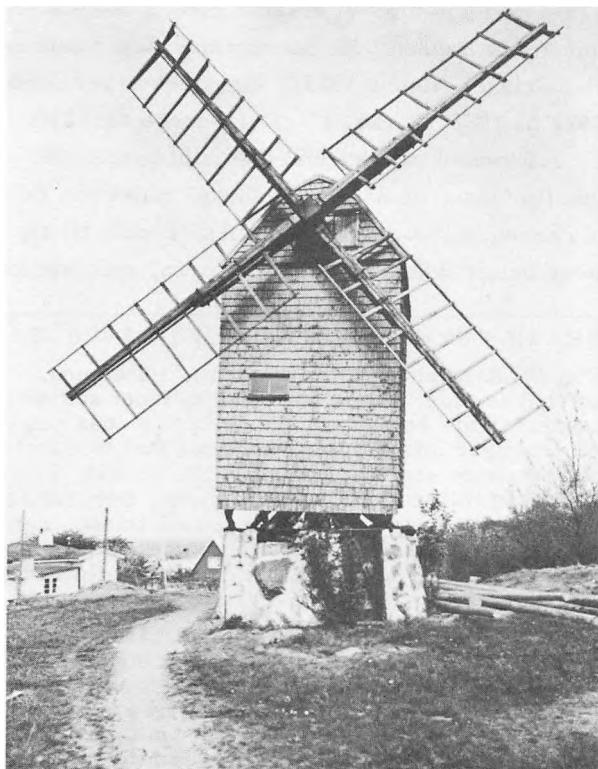
Fig. 37, above : DK-20 057, date 03-06-56, neg. 833.35

BORNHOLM POST MILLS
Only three post mills are still standing on Bornholm. They are all owned by Foreningen Bornholm, who take great pride in keeping them in a decent order. I have recommended the two best examples, pictured above, preserved on TOP PRIORITY as examples of the small and the developed type (with barley processing plant). The third post mill, Egeby Mølle, pictured in page 29, is in a rather poor state, but has by far the best landscape situation of the three. Egeby Mølle stands back some 250 m from the trunk road Rønne-Aakirkeby-Nexø in a most attractive plain, overlooking the southern third of the island. Alone for this reason, I feel inclined to recommend this mill to be preserved on SECONDARY PRIORITY, so much more so, as it is the smallest windmill on the island, and consequently inexpensive to keep. It is the only one of the post mills with its brake wheel mounted on morticed arms.

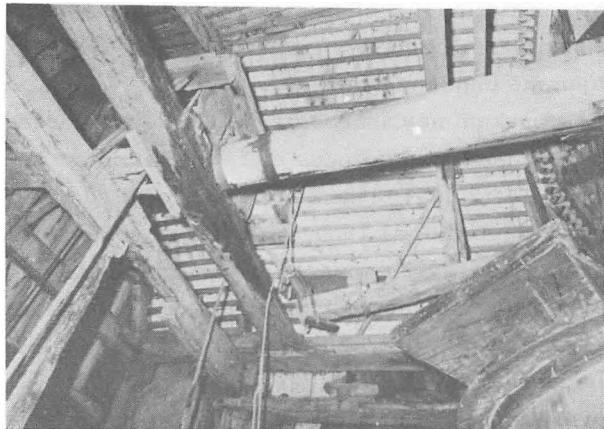
Fig. 39, neg. 834.08

Fig. 39: Stone floor and inside of roof, starboard side. On the left of the photo is the hand-operated sack-hoist. Below it, on the wall, hangs the hand screen, preceding the wire machines, found in DK-20 034. In the centre of the photo is the brake lever, raised by a single pulley arrangement (the operator must lift half the weight of the brake lever, which is hinged in the windward side). Fig. 42 is a continuation of this view.

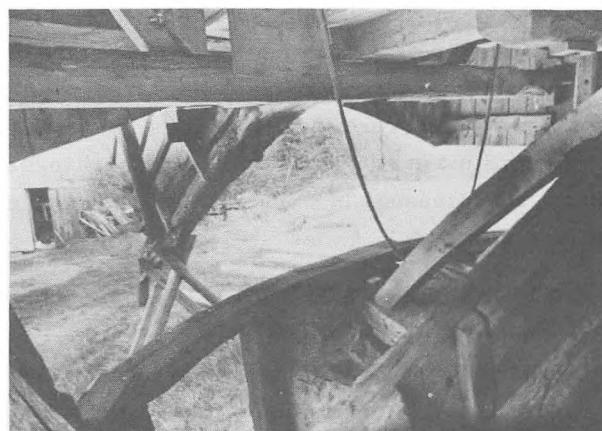
Fig. 42, neg. 834.07

Fig. 42: En fortsættelse til højre (imod vinden) af fig. 39. Hattehjulet sidder paa den vandrette vingeaxle og er i indgreb med det kombinerede kron og kværndrev. Gearet er svagt konisk. Persen omslutter hattehjulet med næsten 360°, sammen ligg med fig. 50. Det runde støvkar er delvis aaben net. Naar møllen er i drift, skal det slutte tæt, og en kile gennem styredornen vil holde karret sammen. Denne kværn er det eneste vinddrevne i denne mølle.

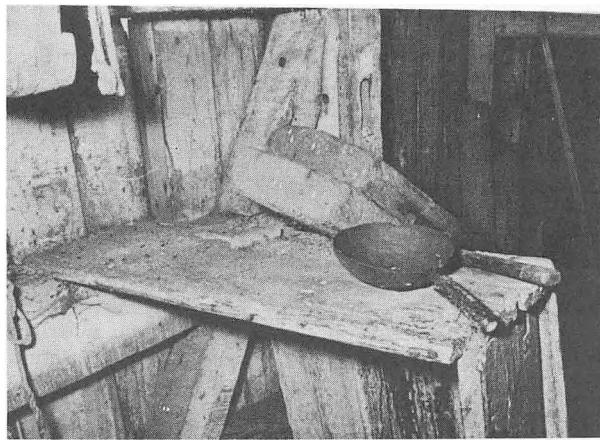
Fig. 47, DK-20 034, date 04-06-56, neg. 840.19

Fig. 47: Toldekoppan ~ the toll cup, with which to take 1/24 or 4.2 % of the processed grain as payment for the work. The above example is the only one, found so far on the island (in DK-20 034).

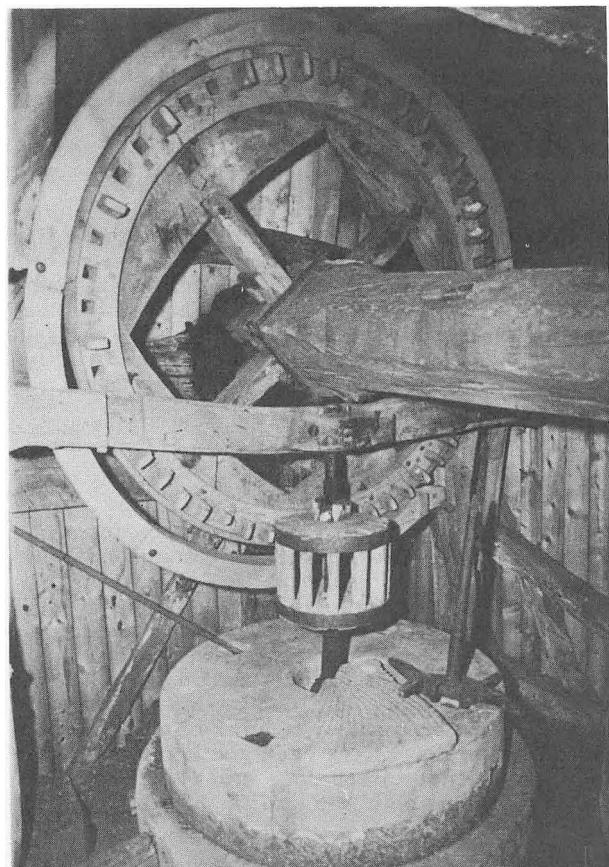
Fig. 48, DK-20 018, date 14-09-58, neg. 1106.34

Fig. 48: DK-20 018-Egeby Mølle. Kværnloftet, set imod vinden. Hattehjulet har armelag, som er stemmet gennem vingeaxlen, den ældste fremgangsmaade; sammenlign med de senere kilede armelag, som ses paa de andre billeder. Persen er faldet fra hjulet og kan derfor folges hele vejen rundt om hattehjulet. Persebommen ligger til højre. Paa kværnen, som har mistet sit ringkar, ligger et firkløver-segl fast forbundet med langjernet; det hele ligger paa hovedet. Dette segl er sikkert det oprindelige, da det langjern, som nu sidder i kværnen, er en drejet staalaxel.

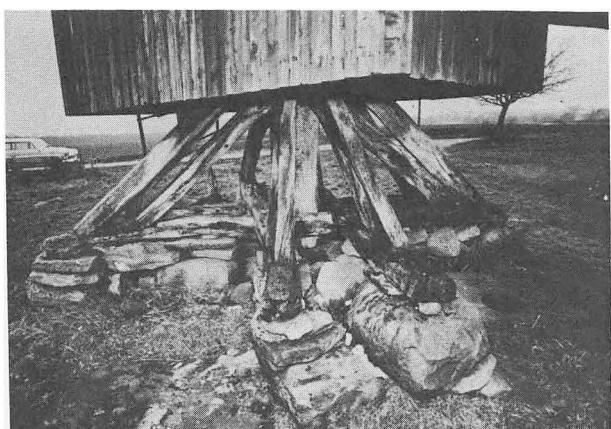
Fig. 49, DK-20 018, date 02-12-56, neg. 875.12

Fig. 49: DK-20 018-Egeby Mølle. The foundation of the mill is in a most alarming condition. It is clear from the illustration, how little wood is left to take the horizontal stress (d-d) in fig. 46.

Fig. 49: DK-20 018-Egeby Mølle. Møllens underbygning er i en overmaade daarlig forfatning. Det ses tydeligt paa billedet hvor lidt træ, der er tilbage til at tage det vandrette træk (d-d) i fig. 46.

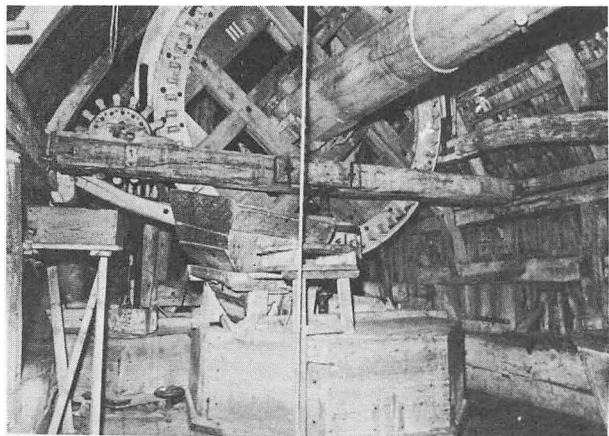
Fig. 50, neg. 840.27

Fig. 50: Kværnloftet med den store melkværn, drevet med eet-trins overtræk fra hattehjulet i midten. Oprindelig har dette sikkert været den eneste kværn i møllen. Til venstre for denne kværn er den styrbords grynbækker, som drives ved to-trins overtræk gennem gearet, som ses paa dette billede og paa fig. 53/54. Et lignende gear maa engang have været anbragt paa bagbords side, hvor der i dag kun er letteværket tilbage af kværnen. Persebommen ses paa bagbords side, og den underste halvdel af selve personen er fjernet for at give plads til de to smaa axler til grynstene.

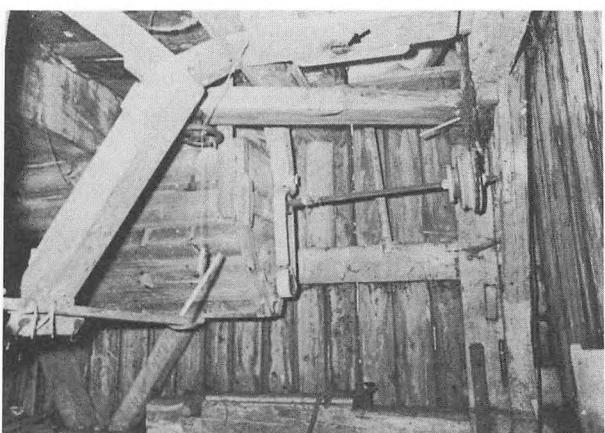
Fig. 55, neg. 840.30

Fig. 55: Broloftet, lige under fig. 53/54. Til venstre ses sigten og dens kædetræk fra vingeaxlen (se fig. 54). Videre ses tuden fra den styrbords grynkærn samt denne kværns skrue-lette (se ogsaa fig. 50 til venstre). Ved pilen ses toplejet til skallekværnens spilstok.

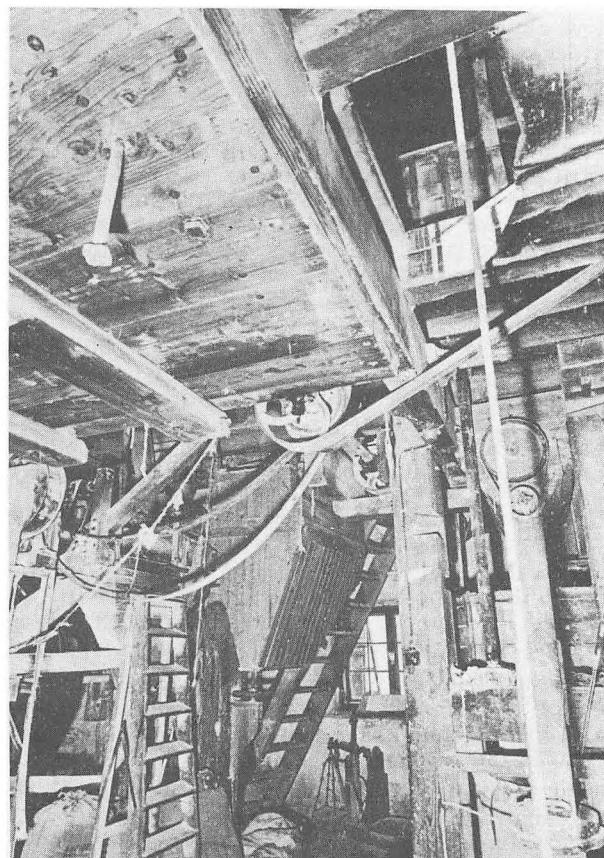
Fig. 70, date 02-06-56, neg. 830.36

Fig. 70: Broloftet, under fig. 69, set fra vestsydvest. I loftet ses den bolt, som engang bar bjælkekassen, hvori skalstenen laa. Den ene faldlem til det sydlige hejseværk er aaben, og herved ses et glimt af kværn nr. 2's stovkar. I baggrunden ses de forskellige sigter, som leverer mel til bageriet. Skrueletten er sandsynligvis af senere oprindelse. Dette loft ligger i jordhøjde.

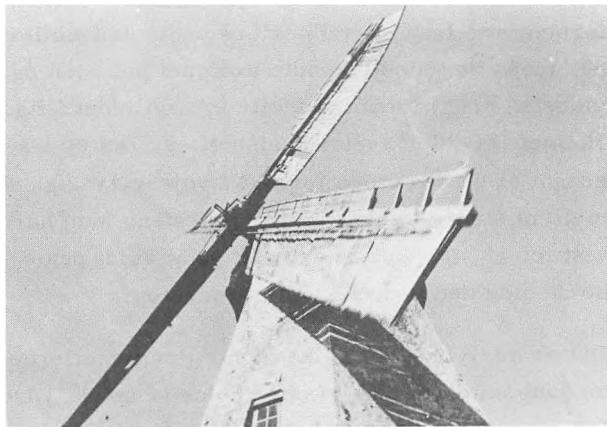
Fig. 71, date 02-06-56, neg. 830.35

Fig. 71: The onesided shutter sail, closed while the mill is in operation (hence the unsharpness in the foreground). The outermost gale board ~ "stormbrædt" has been removed (lost?).

Fig. 71: Det eensidige klapsejl, lukket, naar møllen er igang, deraf uskarpheden i forgrunden. Det yderste stormbrædt er fjernet (gaaet tabt?).

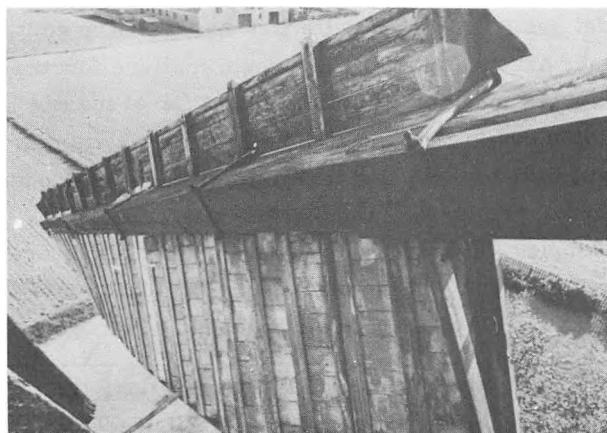
Fig. 73, date 05-06-56, neg. 843.19

Fig. 73: The sweep stock seen from the back, the sails being closed, but the mill being at a standstill. This photograph was taken a few months prior to the demolition of the mill, see fig. 7 & 8. The sweeps are usually composed of a centre stock, "kollan" to which the tips are fastened by means of "jernvidjer", iron straps.

Fig. 73: Vingen set bagfra, sejlene er lukkede, men møllen staar stille. Dette billede blev taget faa maaneder før møllens demontering, se fig. 7 og 8. Vingerne bestaar i reglen af et midterstykke, kollan, til hvilket spidserne er spændt med jernvidjer (jernspændeband).

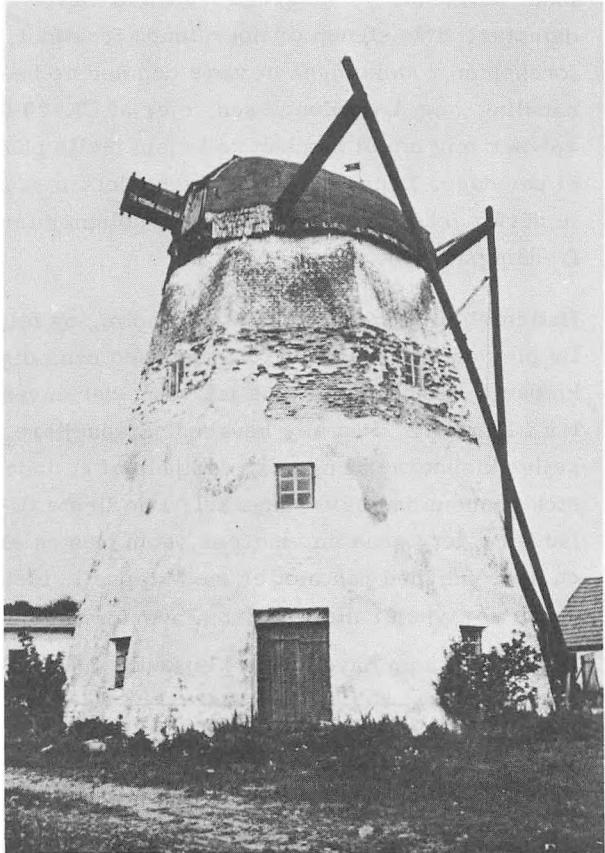
Fig. 79, date 04-06-56, neg. 838.17

Fig. 79: The mill body from the south. The lower half is built in Nexo sandstone (the mill is called Quarry Mill from the adjacent Frederiks Stenbrud ~Quarry), while the top is in brick. The lower part of this brickwork must have been of a very poor quality, as it has become badly attacked by frost, while the masonry above, and below is quite sound after 92 years of service.

Fig. 79: Mølleskroget fra syd. Den underste halvdel er bygget i Nexo sandsten (møllen hedder Stenbrudsmøllen efter det nærliggende Frederiks Stenbrud), mens den øverste del er i mursten. Den underste del af murværket maa have været opført af meget daarlige mursten, som ikke har kunnet taale frosten, mens murværket ovenfor og stenmuren nedenfor har klaret sig fint gen-nem de 92 aar, møllen har staaet.

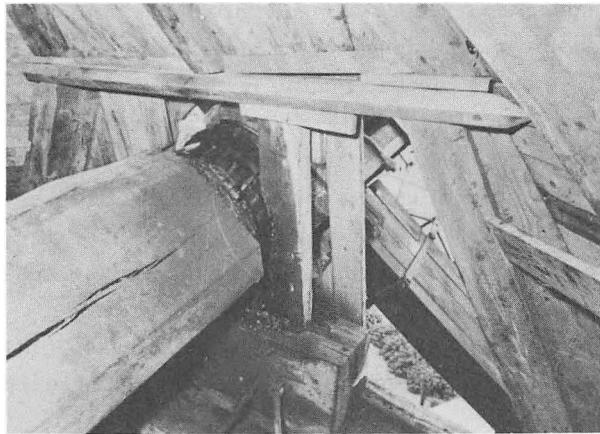
Fig. 84, date 04-06-56, neg. 837.36

Fig. 84: The neck journal of the wind shaft, looking into the wind from the port side. The wind-shaft is all wooden.

Fig. 84: Storesolen (det forreste leje) til vinge-axlen, set imod vinden og fra bagbord. Vinge-axlen er helt af træ.

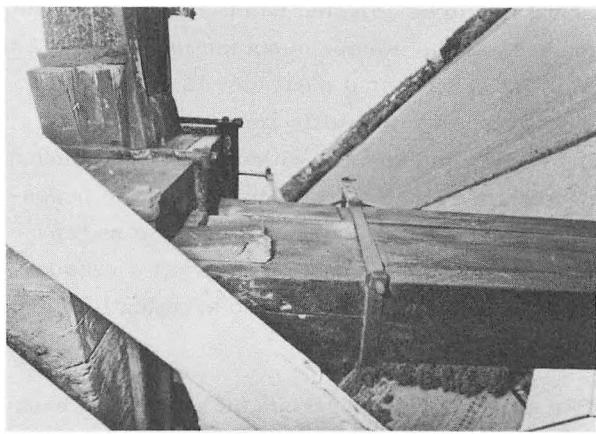
Fig. 85, date 04-06-56, neg. 837.34

Fig. 85: As fig. 84, but further forward (windwards), showing the wedging of the sweep stocks into the mortices of the wind shaft. Note, how the stocks are passing each other in different plans.

Fig. 85: Som fig. 84, men længere fremme, imod vinden. Billedet viser, hvorledes vingerne er stemmet igennem vingeaxlen og fastholdt med kiler. Bemærk, at de to vingestokke passerer hinandenude af plan, saa deres tværnsnit ikke formindskes paa skæringsstedet.

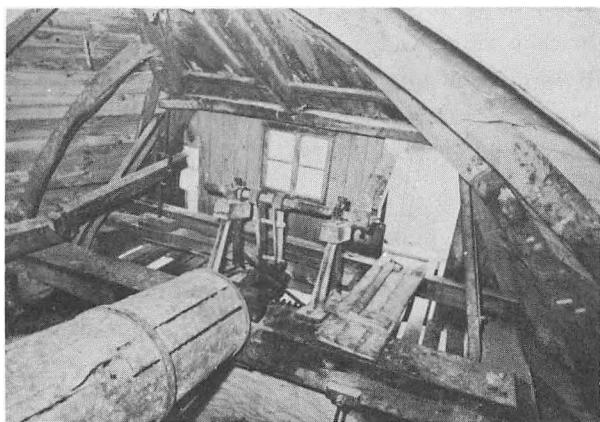
Fig. 86, date 04-06-56, neg. 837.33

Fig. 86: The tail end of the cap, seen with the wind, and from starboard. On the left is the lever elevating the weight-lever of the brake, and in the centre is the striking gear. The striking rod ~ "ladestokken" is pushed back and forward by a lever, fixed on a shaft. On the starboard side of this shaft is yet a lever, which is protruding through back of the cap, and the far end of which is movable from the ground by means of an endless chain, running over a pulley fixed to the fan tail frame work.

Fig. 86: Læsiden af hatten, set med vinden og fra styrbord. Til venstre ses persestangen, som løfter persebommen, hvorved personen frigøres. I midten ses gearet til vingeplapperne. Ladestokken (som løber gennem den hule vingeaxel) kan skubbes frem og tilbage af en vægtstang, monteret paa en kort axel. Paa den styrbords ende af denne axel er fastgjort en lang stang, som rager ud af hatten. Den yderste ende af denne stang kan bevæges op og ned fra jorden ved hjælp af en endeløs kæde, som løber over en trisse, fastgjort til vindrosens stativ.

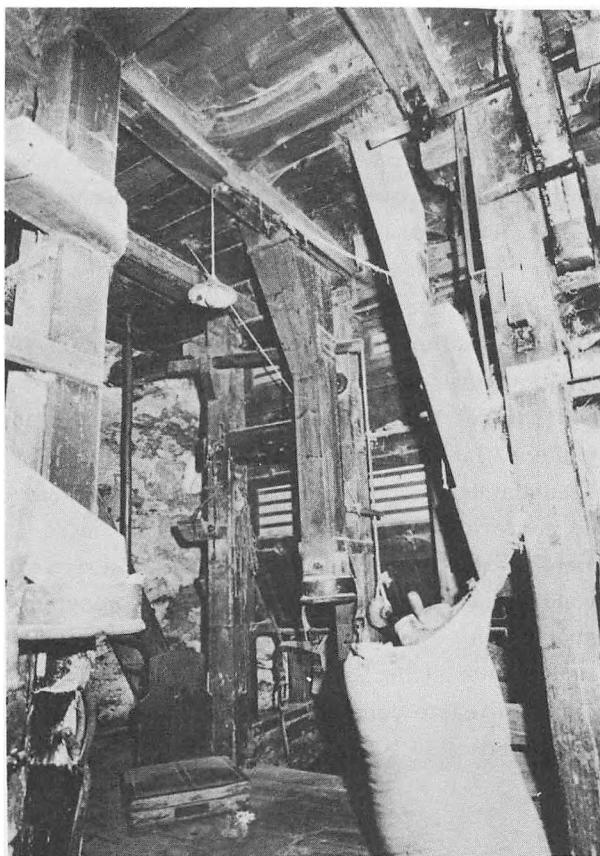
Fig. 87, date 12-10-58, neg. 1109.12 (J. Gell).

Fig. 87: The bridge floor with most of the screens &c intact. Note the parallel tentering lever with the Bornholm speciality: the pulley check rope:

Fig. 87: Broloftet med de fleste sigter og andet maskineri intakt. Bemærk den parallele lettestang med den bornholmske specialitet, taljebet til at holde stangen i stilling:

rebet passerer i alt 3 trisser, og der er ingen mulighed for at betjene stangen ogsaa fra kværnloftet. Maaske er dette grunden til, at saa mange letteværker er blevet erstattet med skrueletter, som kan betjenes fra begge lofter. Denne etages gulv ligger i jordhøjde.

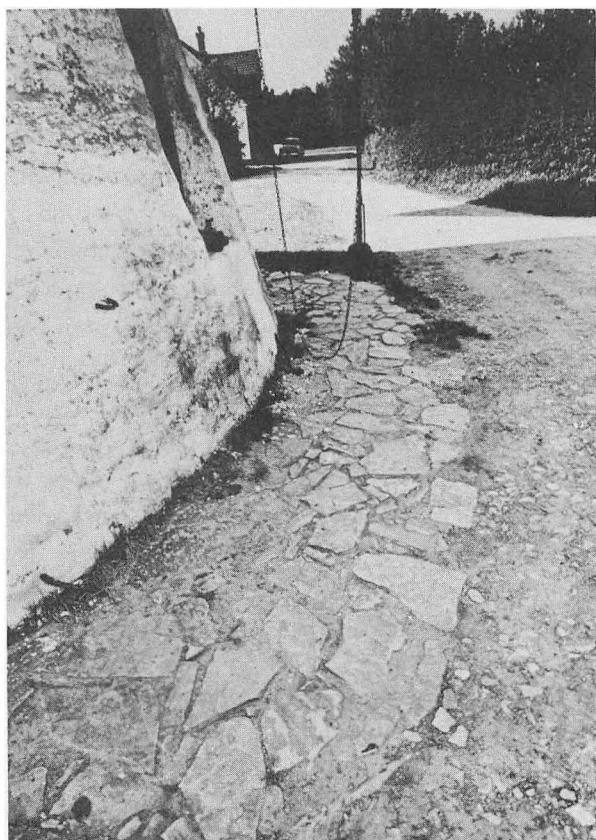
Fig. 88, date 02-06-56, neg. 831.12

Fig. 88: The pavement, once used when the miller walked round, winding the tail-pole winch(the eyelets for the hook of the winch rope is seen on the wall).

Fig. 88: Den brolægning, hvorpaar mølleren engang vandrede, naar han drejede svansens gangspil og dermed krøjede hatten i vinden. Endnu ses øjekrogene, hvori gangspillets tov fastgjordes med en krog.

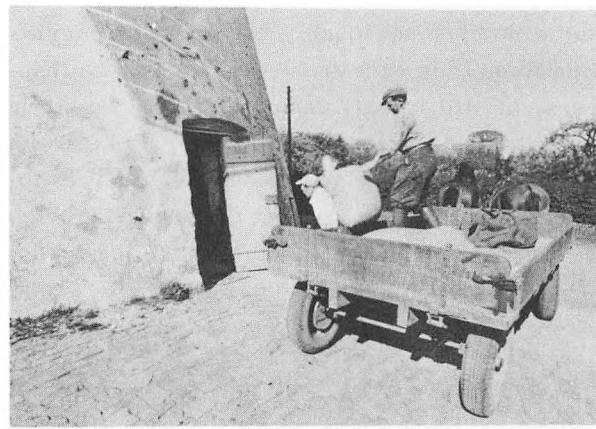
Fig. 89, date 02-06-56, neg. 831.13

Fig. 89: The sandstone has been set vertically where the traffic of the heavy mill carts is to be expected, outside the two doors, leading to the bridge floor of the mill. Even to-day, the grain must be carried into the mill. Note the shadow of the moving sweep over the door.

Fig. 89: Hvor den tunge vogn-trafik kan ventes, udenfor de to døre til møllen, stilles sandstene i brolægningen paa højkant, hvorved en kæntring af stenene forhindres. Endnu i dag maa alt korn bæres til møllens broloft. Bemærk skyggen paa muren af den arbejdende møllevinge.

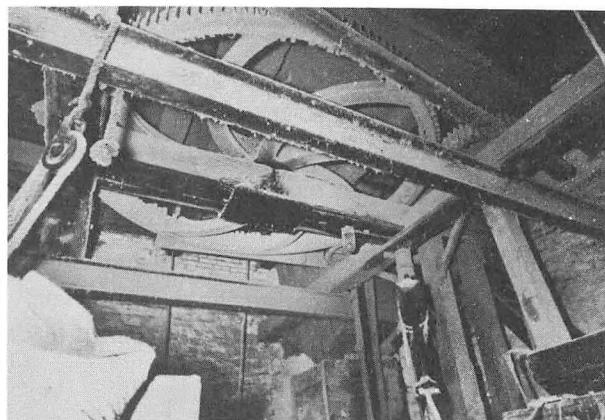
Fig. 114, neg. 832.20

Fig.114: shows the mezzanine floor with the great spurwheel. The second (upright) shaft is intercepted at this level, a SW traditional trend, used in practically all younger windmills. The heavy pine timber has been replaced by steel RSJs, and the gear is all-iron (wooden cogs in the larger wheels).

Fig.114: viser mezzaninefløjet med stjernhjulet. Vellen er standset i denne højde - et SW-traditionstræk, som findes paa alle nyere vindmøller. Det svære pommerske fyr er her erstattet med INP staalbjælker, og gearet er helt af jern (dog er kammene i de store hjul altid af træ).

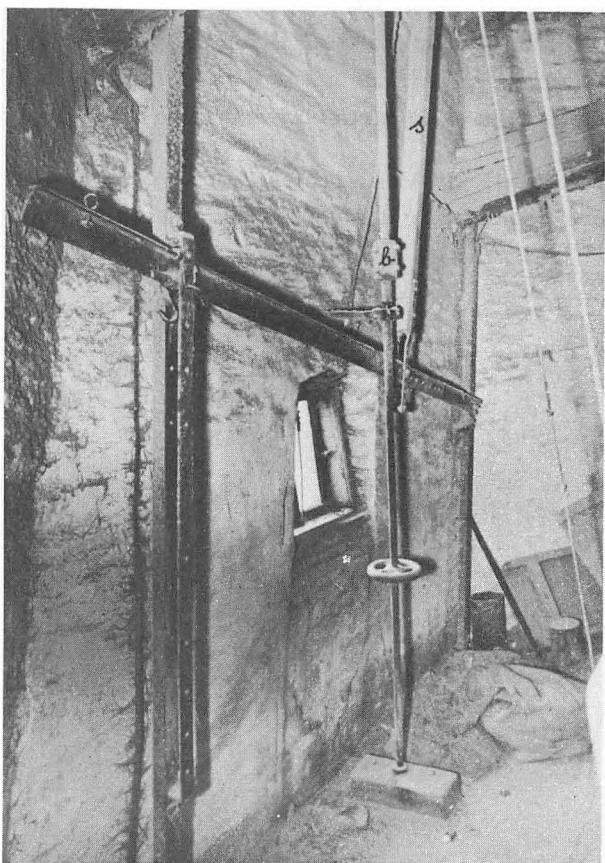
Fig. 115, neg. 832.19

Fig.115: shows the termination on the SE wall of the stone floor of the remote controls of the brake (screw-jack), and the shutters (lever). It was these controls which, indirectly, caused the death of the mill. The one sweep stock became decayed and was removed. The controls being designed to serve two stocks (4 sails), proved unable to handle the remaining stock, and during a gale, the shutters were ruined. On our visit to the mill in 1956 the mill was at a standstill, but yet intact. I have later learned that the mill has now been dismantled, and the memory of this strange piece of millwrighting will survive only on these pages.

Fig.115: viser, hvor persegangen (skrue-hjulet) og svikke-stangen ender paa sydøst-muren paa kværnloftet. Det var disse kontrolorganer, som indirekte blev møllens banemænd. Det ene vinge-par var blevet svækket af raad og blev fjernet. Automatikken var dimensioneret efter 4 vinger og var ude af stand til at klare de 2 under en storm. Klapperne kom i orden, og møllen blev sat i staa. Under vort besøg i 1956 var mølleriet nedlagt, men møllen var stort set intakt. Jeg har senere erfaret, at maskineriet nu er fjernet, og dette nyeste stykke møllebyggerfrembringelse vil kun overleve gennem beskrivelsen paa disse sider.

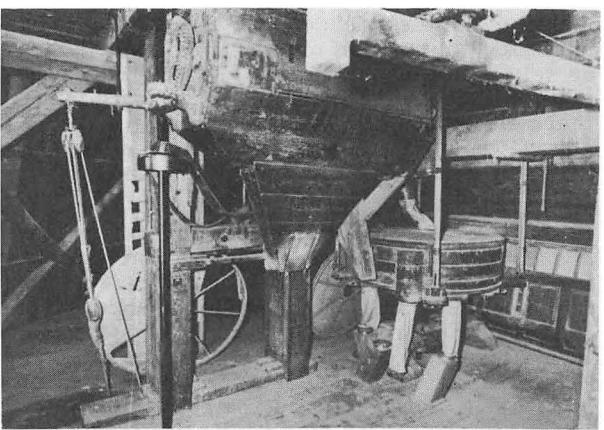
Fig. 122, neg. 839.15

Fig.122: Broloftet. Et nærbillede fra nordvest af den østlige kværn med parallel lettestang holdt paa plads af et reb, som løber over 3 trisser. Foran broværket staar en sigte, og bag denne er en plansigte, og bag denne igen en sorterer.

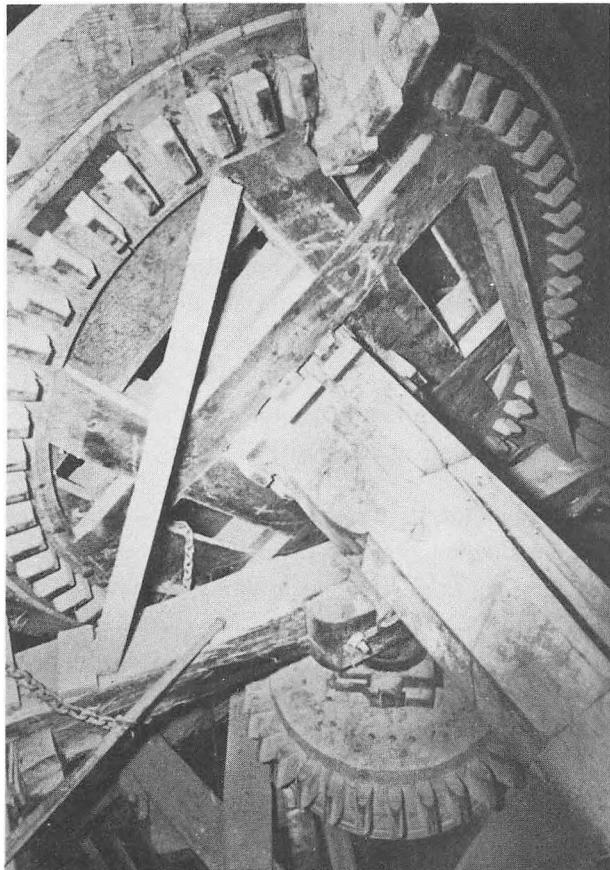
Fig. 126, neg. 835.20

Fig. 126: The brake wheel/wallower of a cap-mill now engine-driven: The brake wheel is securely checked by two posts on the large "krøjebjælke", and a chain is tied through the wheel. 5 "slip" cogs have been improvised, they hang at the top of the brake wheel, and belong in the bottom of that wheel. Their absence allows the wallower cogs to pass without moving the sweeps. Note, the cogged wallower as opposed to the lantern types, seen in the other mills. The sack-hoists run below the wallower. The view is into the wind.

Fig. 126: Hattehjul/krondrev i en hattemølle, som nu er motordrevet: Hattehjulet er sikkert forankret med to stolper ned paa den store krøjebjælke og en kæde bundet gennem hjulet. 5 "sæt-kamme" er improviseret, de hænger oppe i toppen af hattehjulet og hører i virkeligheden til i den nederste del af samme hjul. Deres fraværelse tillader krondrevets kamme at passe, uden at vingerne drejer med. Bemærk, at krondrevet her har kamme og ikke stokke som paa de andre møller. Hejseskiverne løber paa undersiden af krondrevet. Billedet er taget imod vinden.

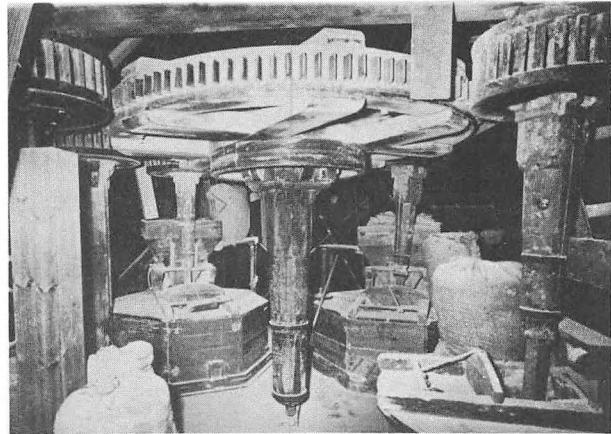
Fig. 127, neg. 835.14

Fig. 127: The stone floor, just below the cap (see the sectional sketch at the end of the book), seen from SE. Left to right: auxilliary drive (5), inter-shaft to barley stone (1), grinding stone (2) grinding stone (3), grinding stone (4). Note that stone (2) and (3) have octagonal vats, while (4) has a round vat. The round vat is usually the younger.

Fig. 127: Kværnloftet, lige under hatten (se snittet af møllen i faksimiliafdelingen, bag i bogen), set fra sydøst. Venstre til højre: træk til diverse maskiner (5), mellem-velle til skalkværnen (1), kværn (2), kværn (3), kværn (4). Bemærk, at kværn (2) og (3) har ottekantede støvkar, mens kværn (4) har rundt kar. Det runde kar er i reglen det yngste, hvor de to kar findes i samme mølle.

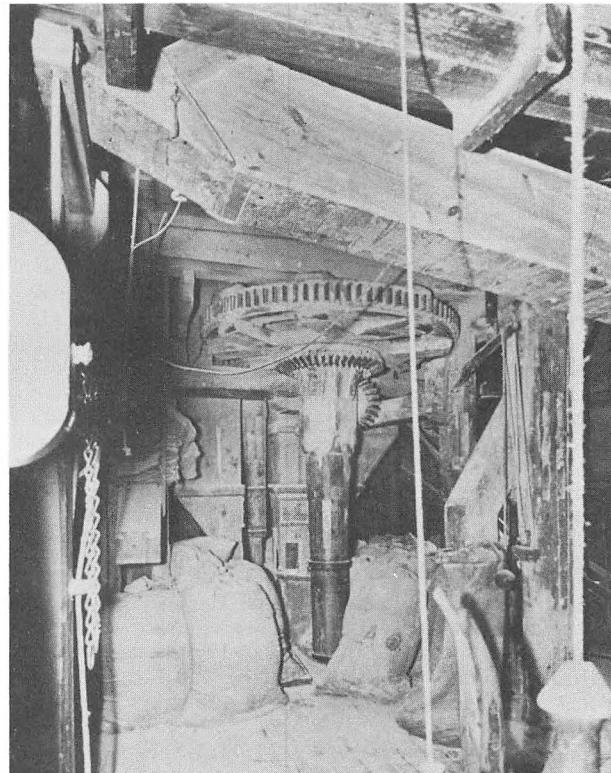
Fig. 128, neg. 835.09

Fig. 128: The bridge floor, immediately below fig. 127, but seen from the north. Shaft (1) is seen in the background, engaging with shaft (6) of the barley stone. Note, the parallel tentering lever on the right, checked by a combined friction and pulley rope. Below the ceiling are the worm troughs, where flour is conveyed horizontally by a wooden Archimedean screw.

Fig. 128: Broloftet lige under fig. 127, men set fra nord. Velle (1) ses i baggrunden, hvor den er i tøj med spilstok (6) til skalkværnen. Bemærk den parallele lettestang til højre. Den holdes i stilling at et kombineret friktions- og trissereb. Under loftet hænger snegle-trugene, hvorigennem melet transportereres vandret ved hjælp af en Archimedes skrue af træ.

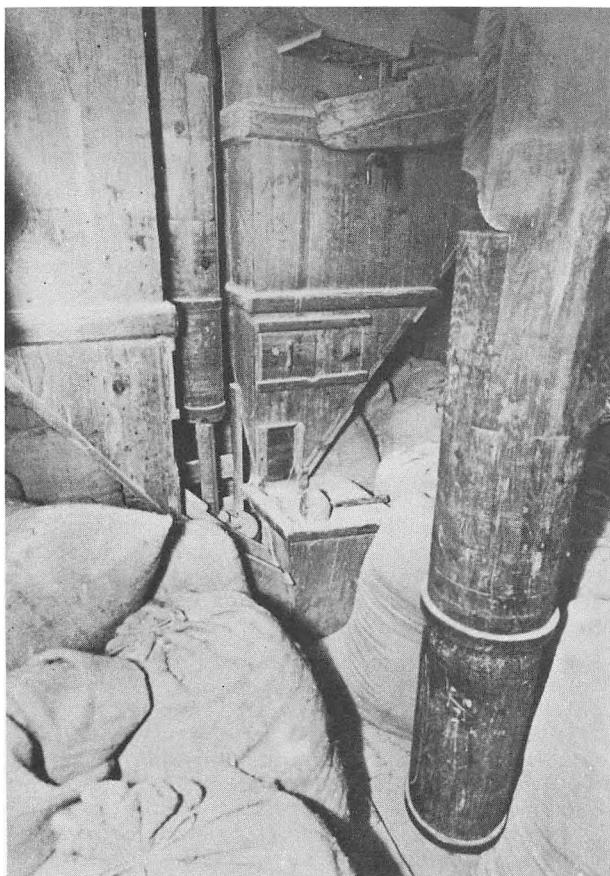
Fig. 129, neg. 835.21

Fig. 129: is a close-up of fig. 128. Here, the barley bins are separated by the barley stone spindle (compare with fig. 97), but the hopper, and even the mallet are identical features. Alas, the barley stone has been removed, and the pipe from a hammer mill passes through the hole in the floor. The old parts, however, are still kept, and a later restoration appears possible.

Fig. 129: er et nærbillede af fig. 128. Paa denne mølle er de to siloer adskilte af skalkværnets spilstok (sammenlign med fig. 97), mens kuben og selv trækøllen er identiske træk. Desværre er skalstenen nu fjernet, og røret fra en hammermølle kommer i stedet op gennem hullet i gulvet. De gamle dele er imidlertid bevaret, og kværnen skulle kunne rekonstrueres paa et senere tidspunkt.

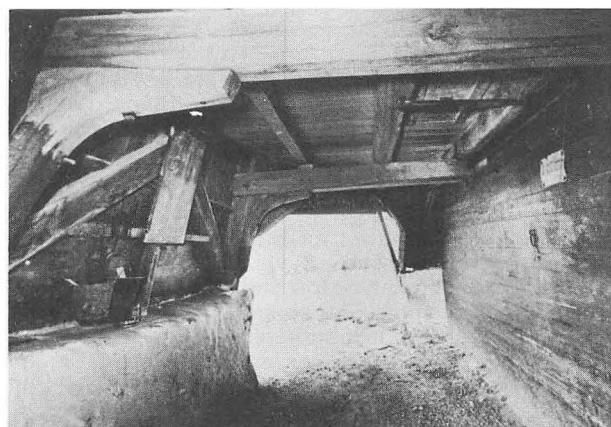
Fig. 130, neg. 835.06

Fig. 130: The pend seen from the west. Note, how crooked timber has been used for brackets to support the beams, and to take some of the momentum, taken by the struts at the other joints. The brackets give better room for the mill carts, passing below the trap-doors of the hoist. The thin string on the right connects to a bell upstairs. Compare this convenience of loading and unloading by hoist, and sheltered from the weather, with the athletic exhibition in fig. 89. !!

Fig. 130: Porten set fra vest. Bemærk, hvorledes krumvokset tømmer er anvendt til konsoller under bjælkerne for tillige at kunne tage noget af momentet, som optages af kopbaandene i de andre samlinger. Konsollerne giver bedre plads til møllevognene, som passerer under hejseværkets faldlem. Den tynde snor til højre fører op til klokken. Sammenlign disse bekvemme ind- og udladningsforhold med hejseværk og beskyttet mod vejrliget med den atletiske opvisning paa fig. 89 !!

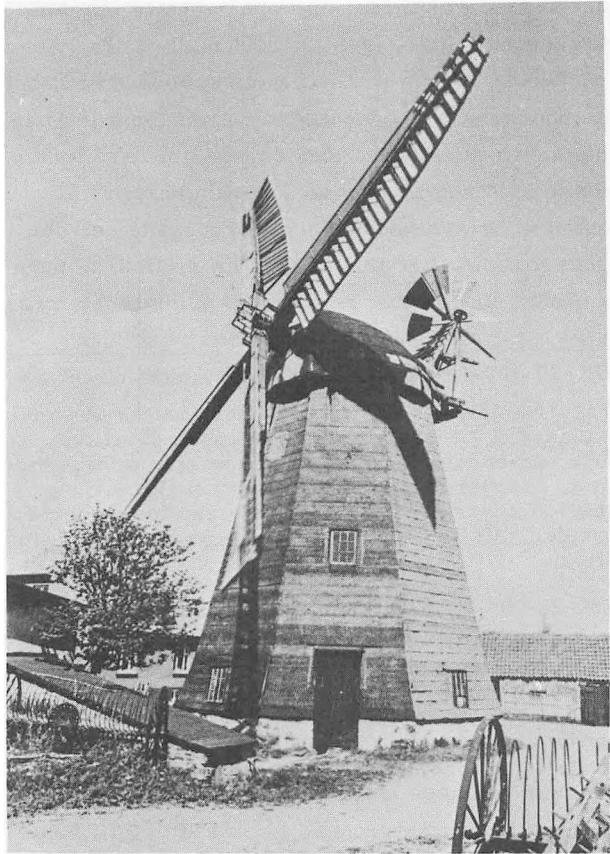
Fig. 131, neg. 830.16

Fig. 131: Ny Mølle is surrounded by the urban development of Allinge, and in consequence of less significance to the landscape than e.g. Svanemøllen. On the other hand, it is more intact, and it is still in use by wind power. The present view is from the southwest, the sweeps facing a westerly wind.

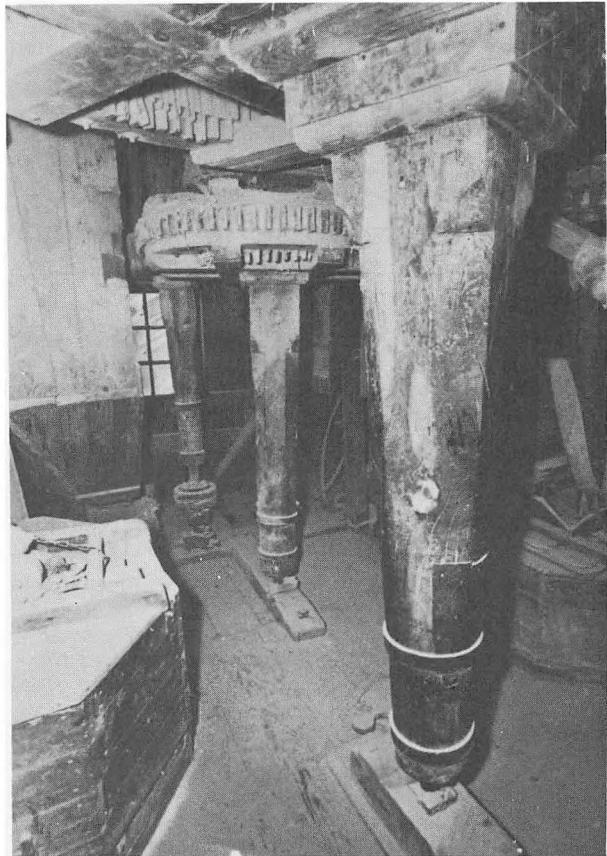
Fig. 132, neg. 830.06

Fig. 132: The stone floor, showing the stone & brick mill arrangement of the barley stone (as opposed to the wood mill tradition of placing the third gear step and the barley stone on the bridge floor, below.) In this particular mill, the reason for not doing so may be that the granite is so close to the surface. Burying the barley stone on the bridge floor (which in this type of mill is on the ground) would then necessitate blowing the rock to make room for the stone. The barley stone has a free wheel arrangement. Compare with previous mills and with fig. 141.

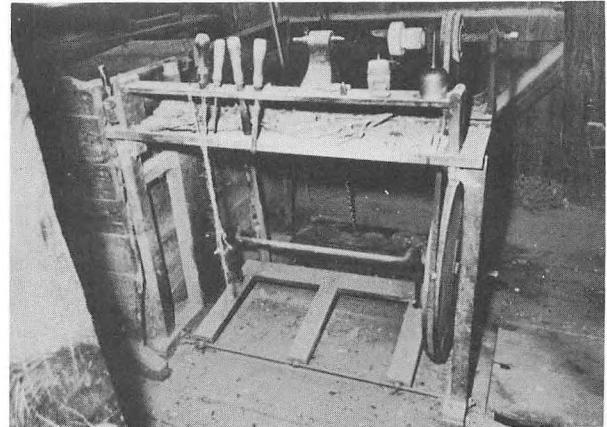
Fig. 133, neg. 830.11

Fig. 133: A lathe, standing on the lorris loft, and used occasionally for smaller repairs in the mill. On a peg on this floor used to hang a pair of field glasses, with which the miller used to keep himself informed about ships, passing by !

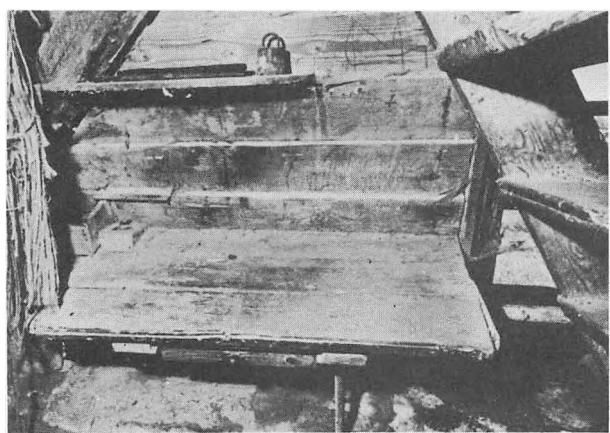
Fig. 135, date 14-09-58, neg. 1106.25

Fig. 135 : The miller's desk on the ground floor (bridge floor) at the NNE cant post. This type of desk is found in most mills, but never before have I seen a so simple, yet so effective way of keeping the drawer below the table closed to unauthorized people: The opening of this drawer puzzled me for 5 minutes, until the miller - grinning - put his finger on the right place, and the drawer could be opened, easily !

Fig. 135: Møllerens pult på broloftet (i jordhøjde) ved det nordnordøstlige højben. Denne slags pulte findes i de fleste møller, men jeg har aldrig set en saa simpel og dog saa effektiv maade at holde skuffen under bordpladen lukket for uvedkommende: jeg prøvede forgæves i 5 minutter at åbne skuffen, indtil ejeren - smilende - satte fingeren på det rigtige sted, hvorefter skuffen med lethed lod sig åbne !

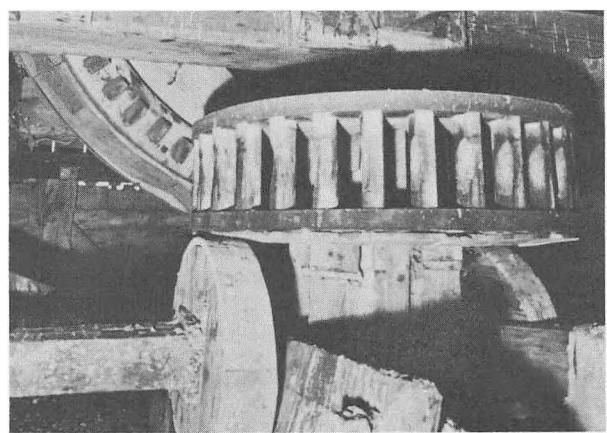
Fig. 136, date 14-04-57, neg. 920.04

Fig. 136: Strandmøllens hat med det sædvanlige gear. Krondrevet er her et cylinderisk stokkedrev, og hattehjulet et kronhjul. De to hejseværker løber under krondrevet.

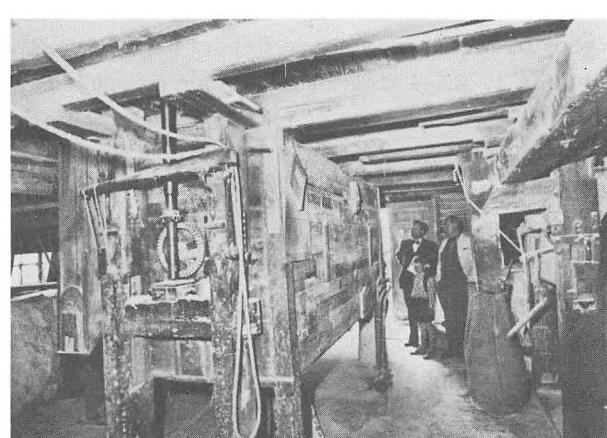
Fig. 142, neg. 834.20

Fig.142: Broloftet i jordhøjde, set fra syd. Kværnen i forgrunden driver den store melsigte ved et konisk drev fra langjernet.

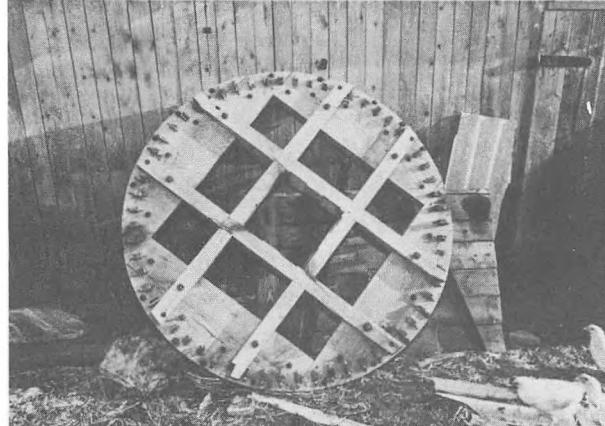
Fig. 147, neg. 844.05

Fig. 147: Of the body itself there was no trace. We were shown the place in the corner of a field, where the mill had been standing. The gearing was found, scattered over the farm premises: Here is the brake wheel, still in excellent condition.

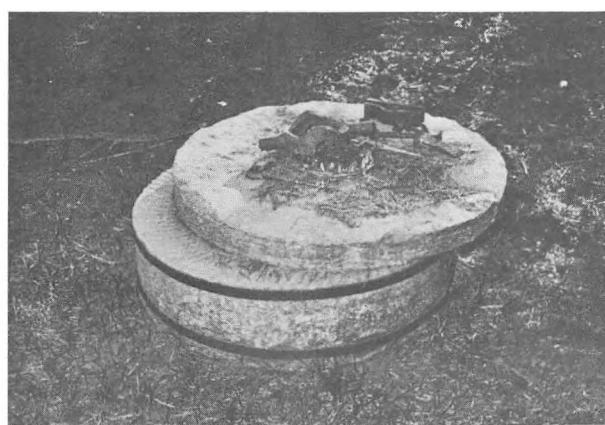
Fig. 151, neg. 844.02

Fig. 151: viser de to møllesten og deres medbringer (balancen ligger et andet sted).

Det er overraskende, at en saa lille mølle blev bygget som en mekanisk kopi af de større møller, mens vi paa Lolland-Falster finder en eet-trins gaardmølle, gearet som stubmøllen, men med en krop som en hattemølle. Jeg har foreslaet, at Bornholms Museum sikrer sig et eller flere af disse gearhjul til udstilling i Museet. Dette ville avertere mollesagen for museumsgæsterne og tillige, i beskeden grad, medvirke til at redde lidt af den sidste gaardmølle paa øen.

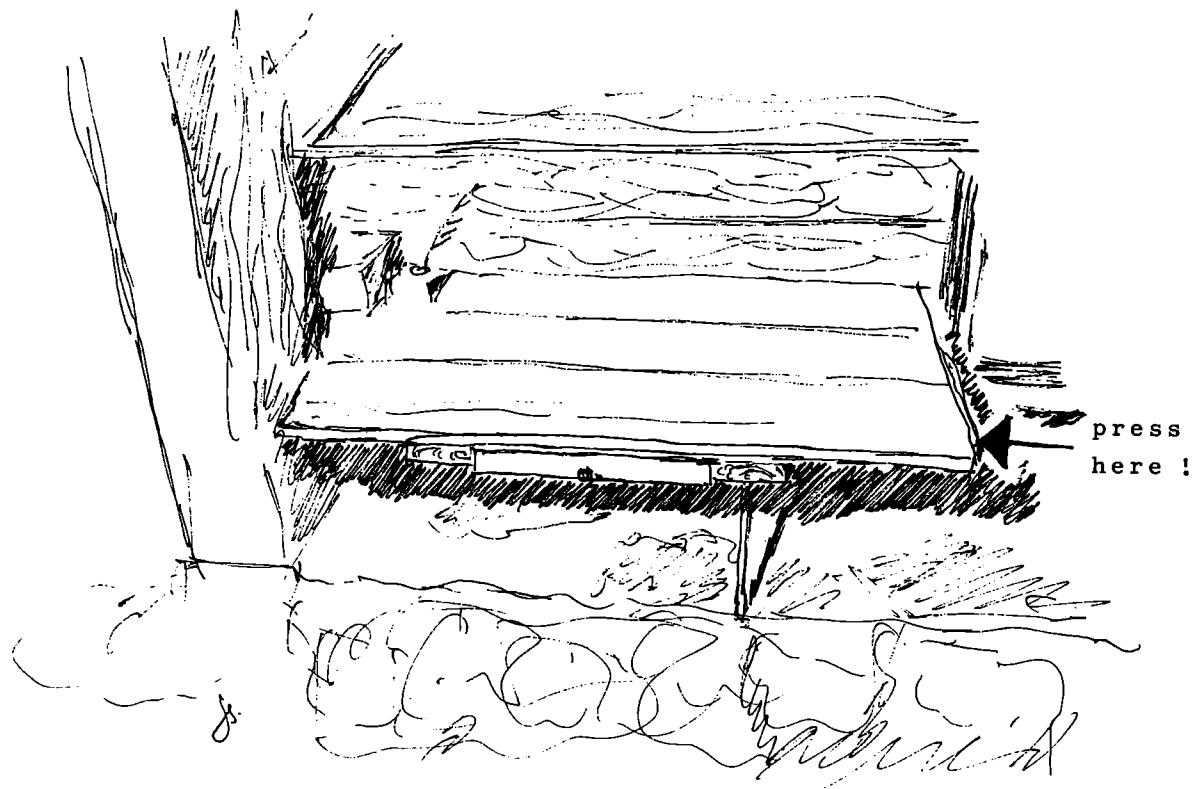
Solution to the riddle of the locked drawer in fig.
135 (fig. 156, below):
